# **INDOOR AIR QUALITY ASSESSMENT**

**Newman Elementary School  
1155 Central Street  
Needham, Massachusetts 02492**

Prepared by:  
Massachusetts Department of Public Health  
Bureau of Environmental Health  
Indoor Air Quality Program  
May 2008

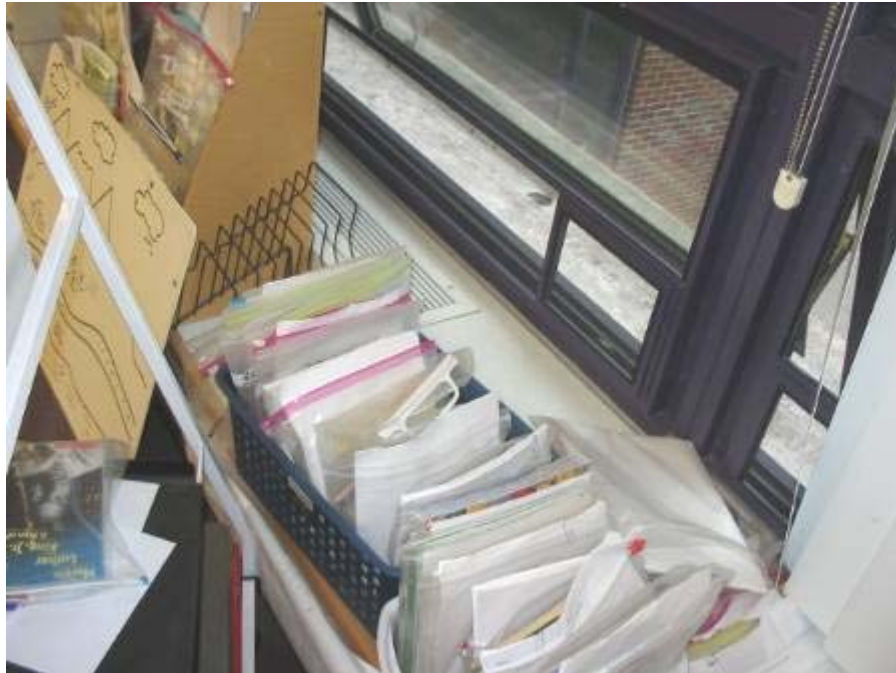
**Picture 1**

**Items in front of supply vent**

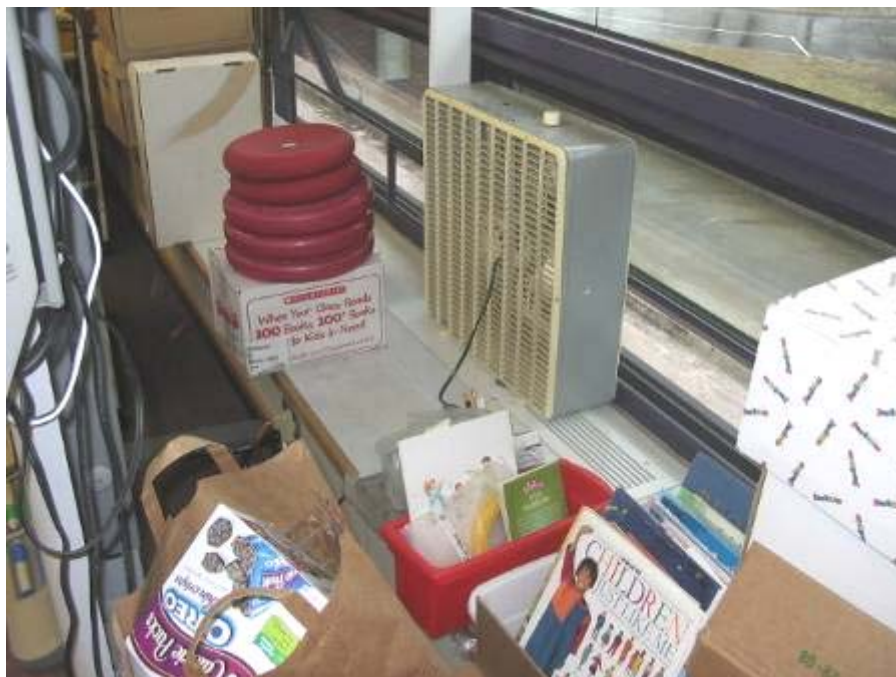
**Picture 2**

**Personal fan placed on top of supply vent**

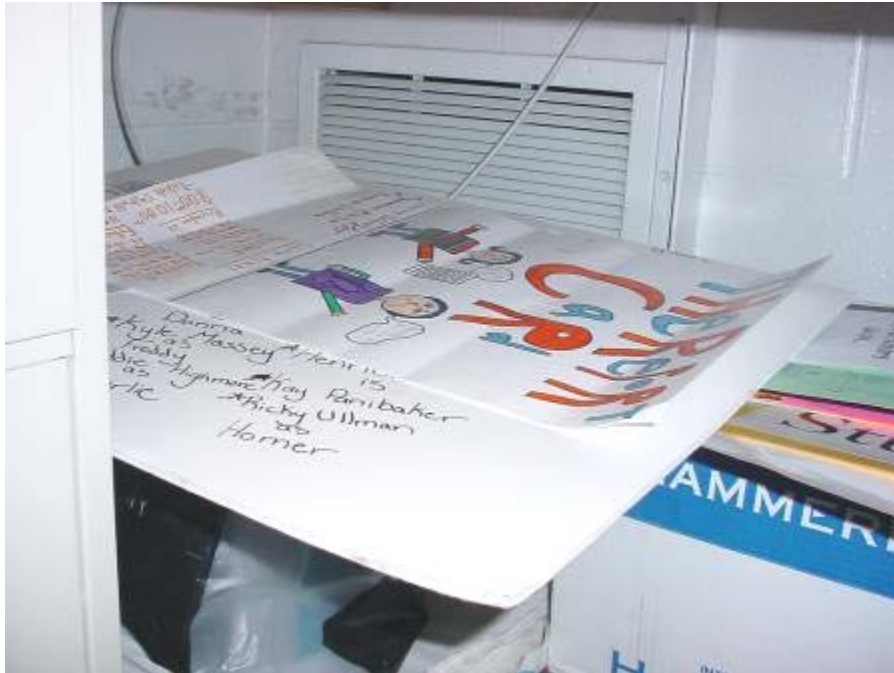
**Picture 3**

**Exhaust vent (located under a counter) blocked by boxes**

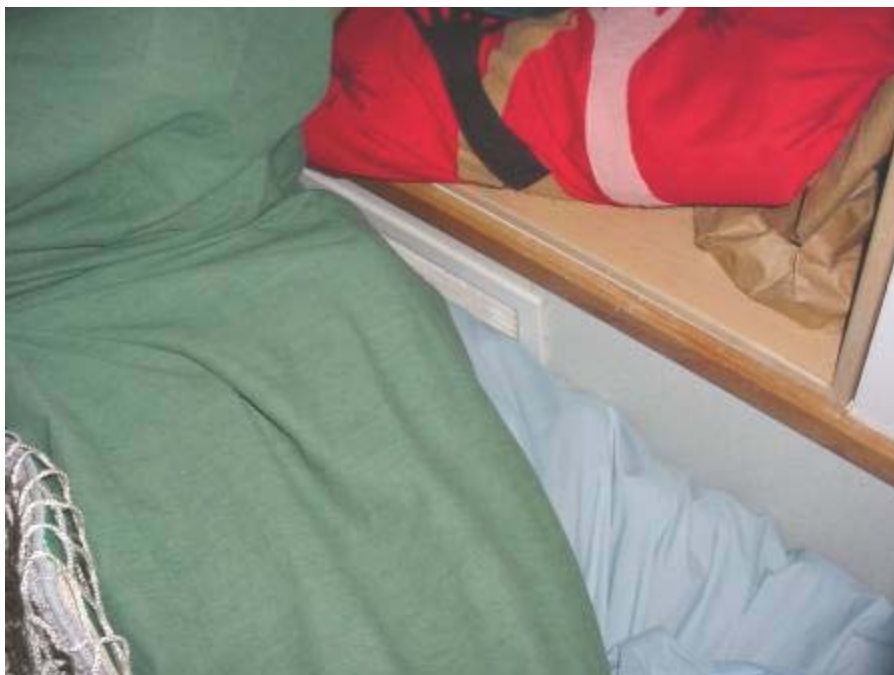
**Picture 4**

Large throw pillows and upholstered furniture (i.e., couches) were seen in a few classrooms (Pictures 4 and 37). These upholstered items are covered with fabric that comes in contact with human skin. This type of contact can leave oils, perspiration, hair and skin cells. Dust mites feed upon human skin cells and excrete waste products that contain allergens. Further, increased relative humidity levels above 60 percent can perpetuate dust mite proliferation (US EPA, 1992). In order to remove dust mites and other pollutants, frequent vacuuming of upholstered furniture is recommended (Berry, 1994). It is also recommended that

**Exhaust vent blocked by upholstered items**

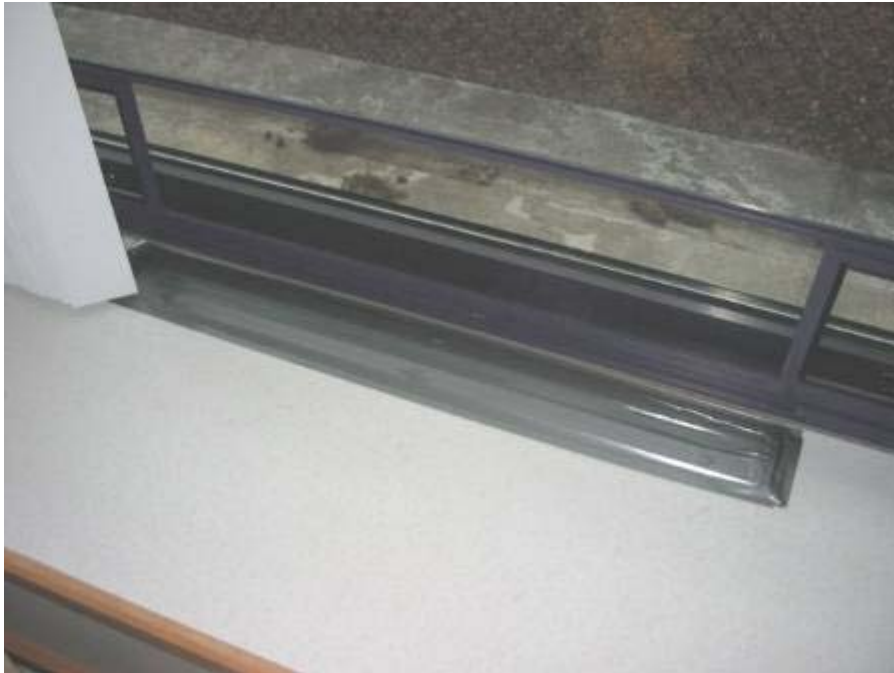
**Picture 5**

**Classroom supply vent sealed with duct tape**

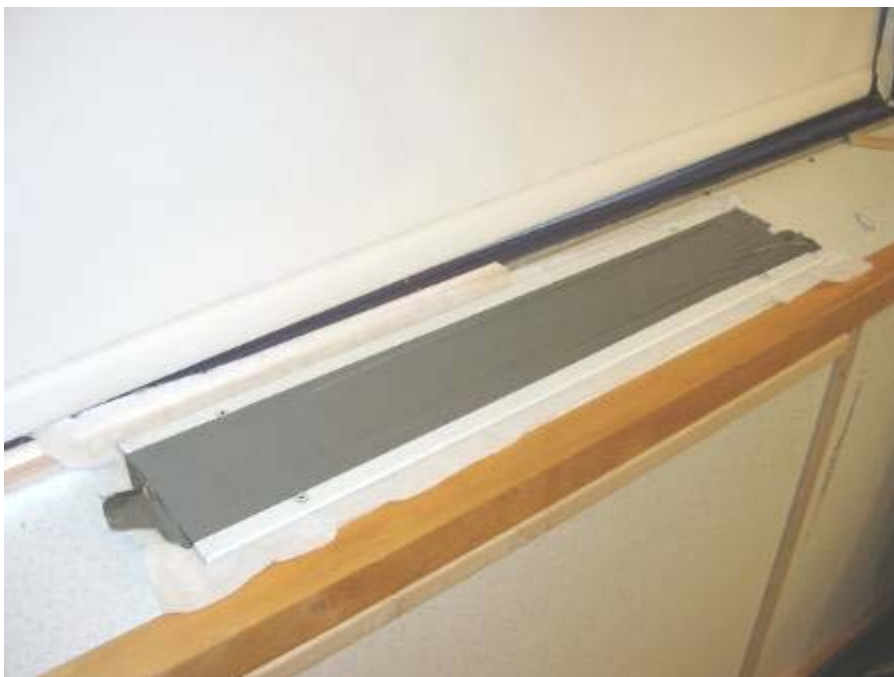
**Picture 6**

**NEAT center supply vent sealed with filtering medium and duct tape**

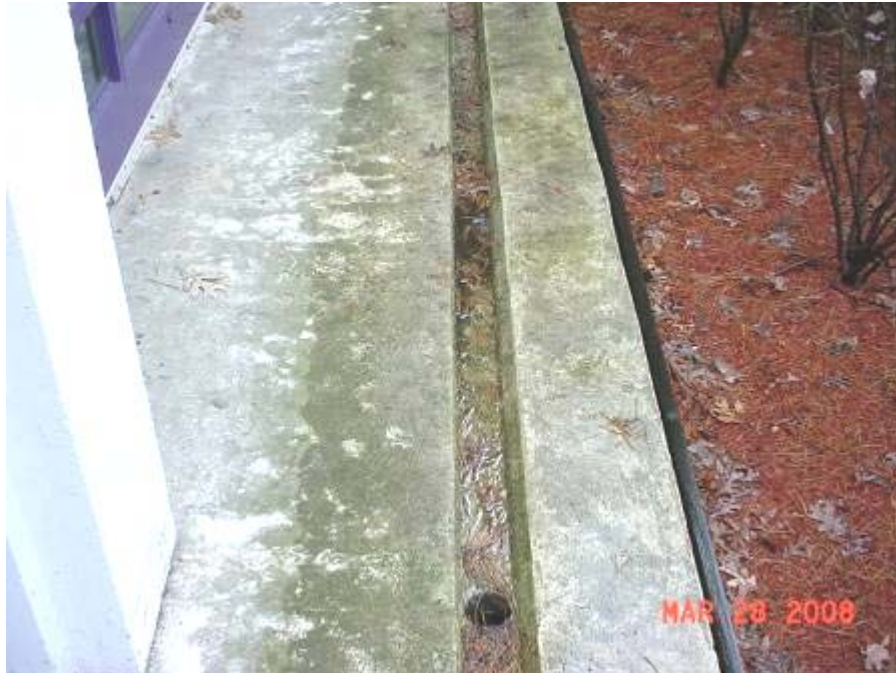
**Picture 9**

**Drainage for cement slab ledges**

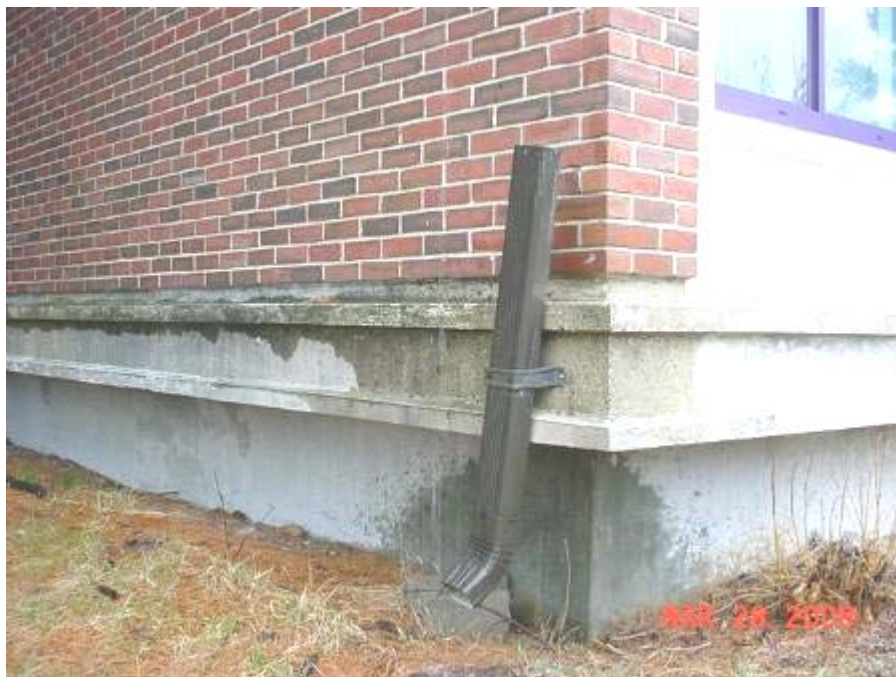
**Picture 10**

- **Lack of downspouts:** Gutters and downspouts in several areas were observed to be damaged and/or missing (Pictures 10 and 11). As a result, water was emptying against the exterior of the building, allowing rainwater to pool on the concrete ledges extending from the window system and the ground at the base of the building.

**Disconnected downspout, note moss growth**

5. Repair/replace all damaged/missing gutters and downspouts, particularly the one servicing the media center walls.
6. Consider erecting a shield over the media center fresh air intake pit to prevent and reduce water penetration.

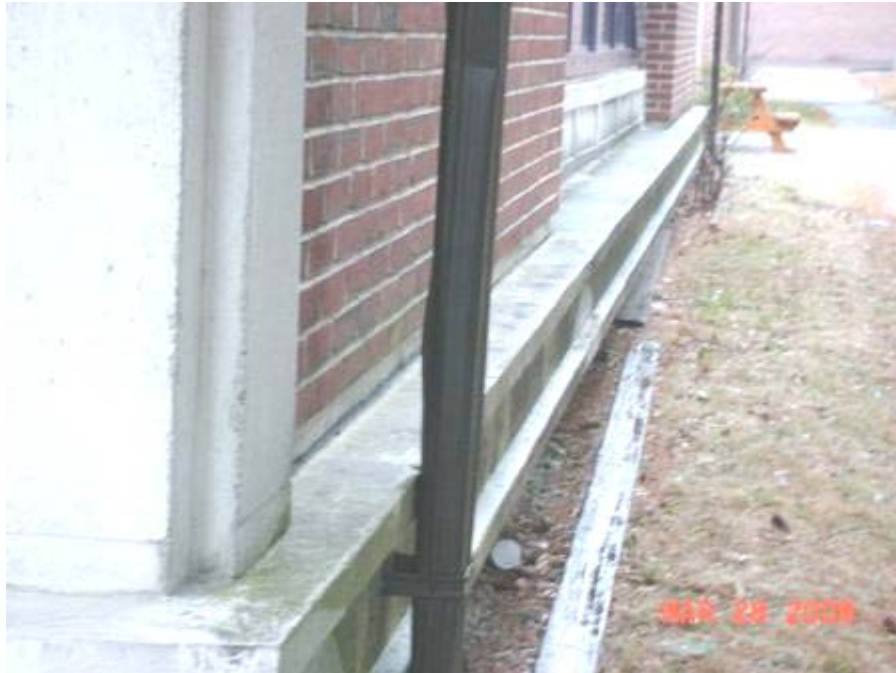
**Picture 11**

**Damaged downspout, note moss growth**

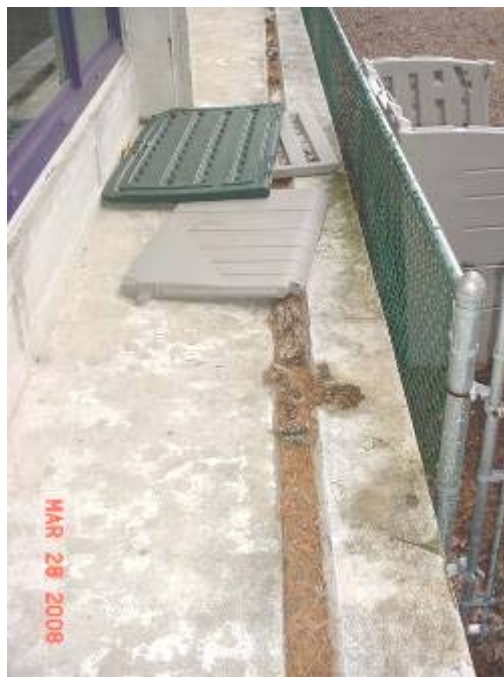
**Picture 12**

- **Clogged drainage systems:** Pine needles and other debris were observed to be clogging intact gutters/downspouts and drainage holes on the building's ledges (Picture 12).

**Clogged drainage trough**

11. Repair all cracks in the cement of the ledges and exterior wall.
12. Remove pine needles and other materials from the ledges to aid drainage.
13. Seal all seams of exposed ductwork in the media center crawlspace.

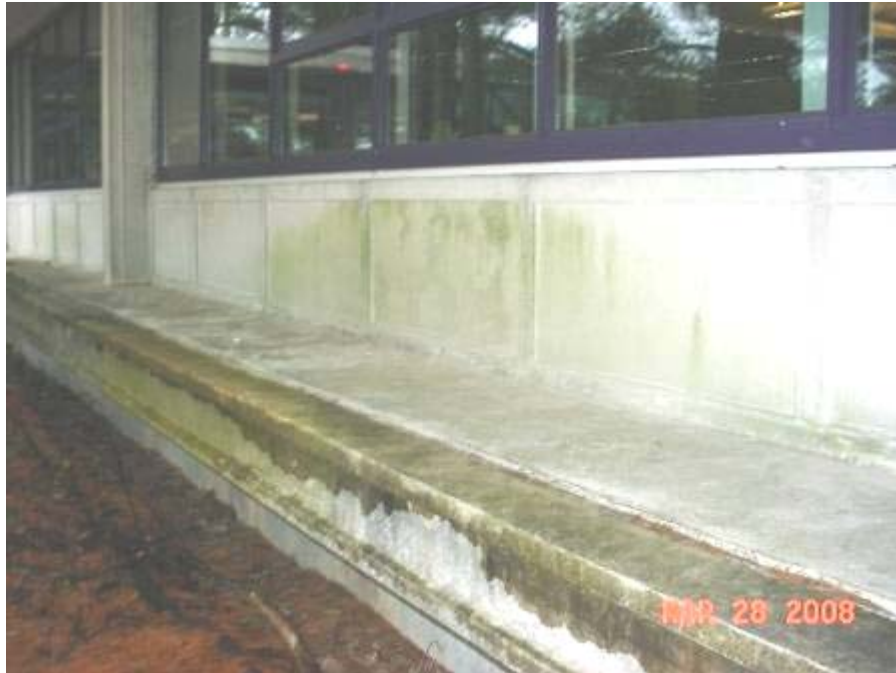
**Picture 13**

- **Moss growth:** Exterior brickwork and cement at the corners of the building, especially in the media center area, appear to be chronically wet and moss growth was observed (Pictures 13 and 14). Moss growth is a sign of heavy/continuous water exposure which can undermine the structural integrity of the brick and mortar by holding moisture against the building.

**Moss growth**

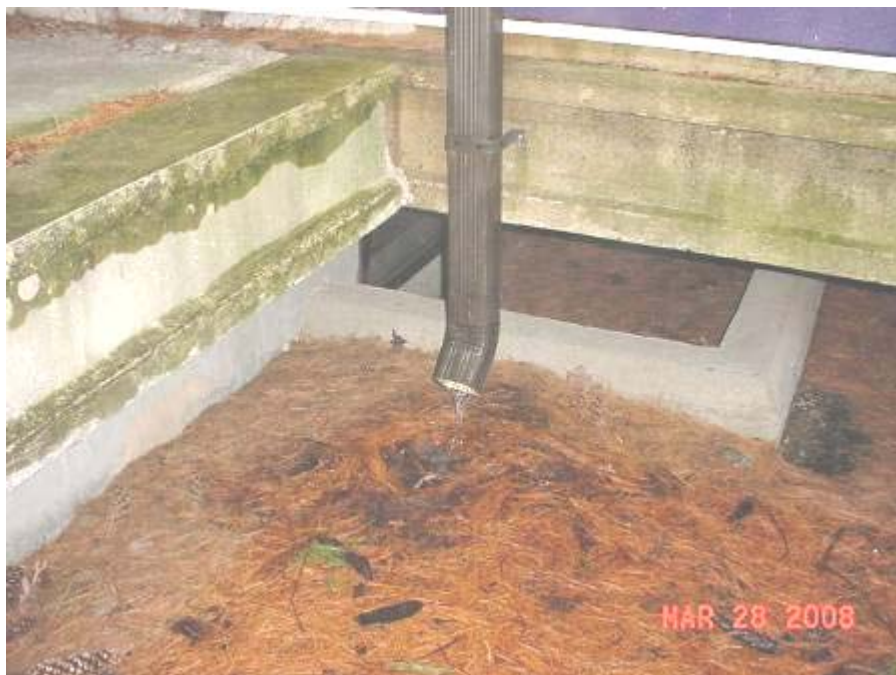
**Picture 14**

**Moss growth**

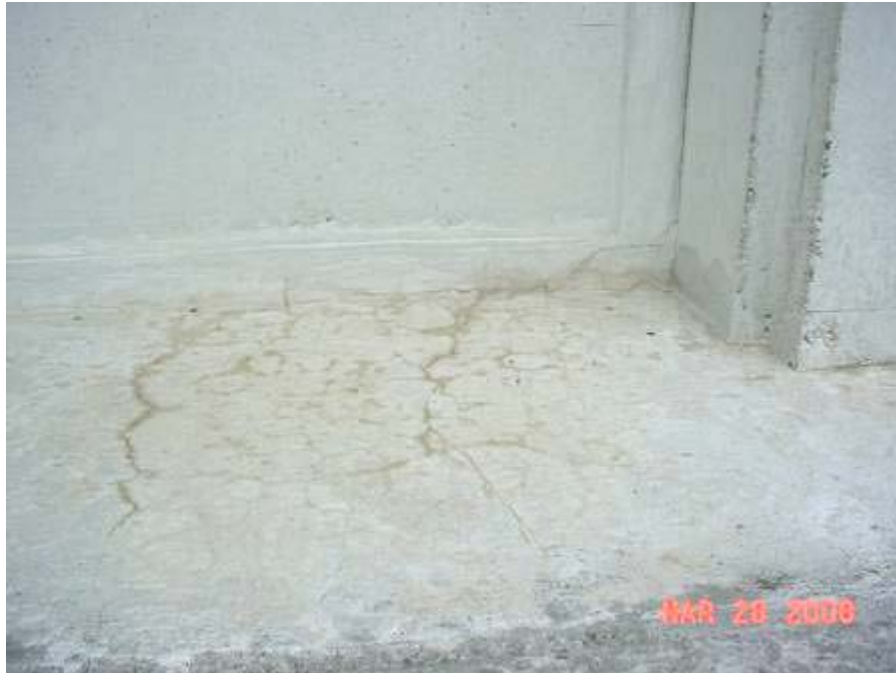
**Picture 15**

**Cracks in exterior cement wall**

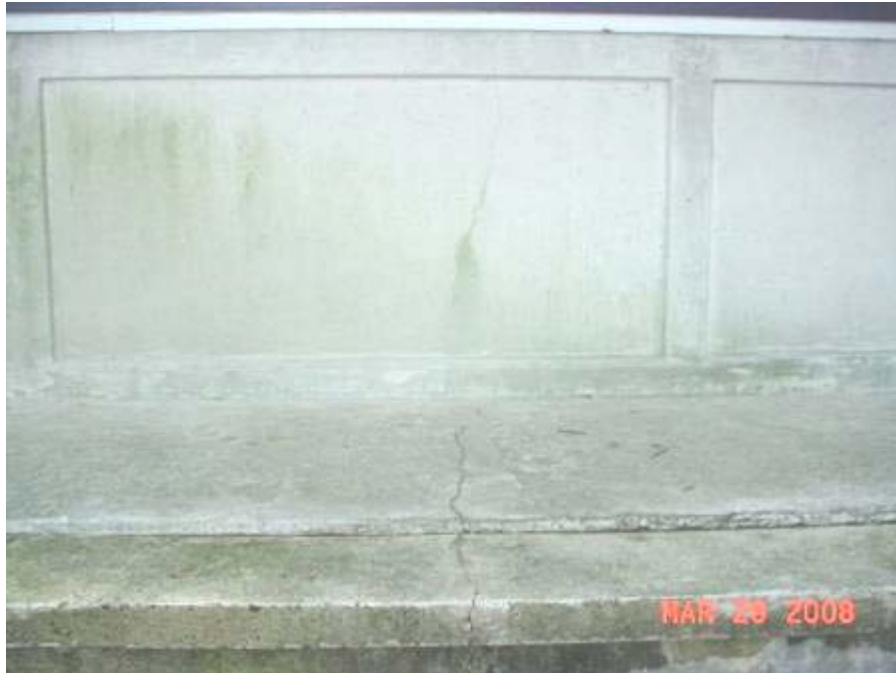
**Picture 17**

**Cracks in exterior wall, note moss growth**

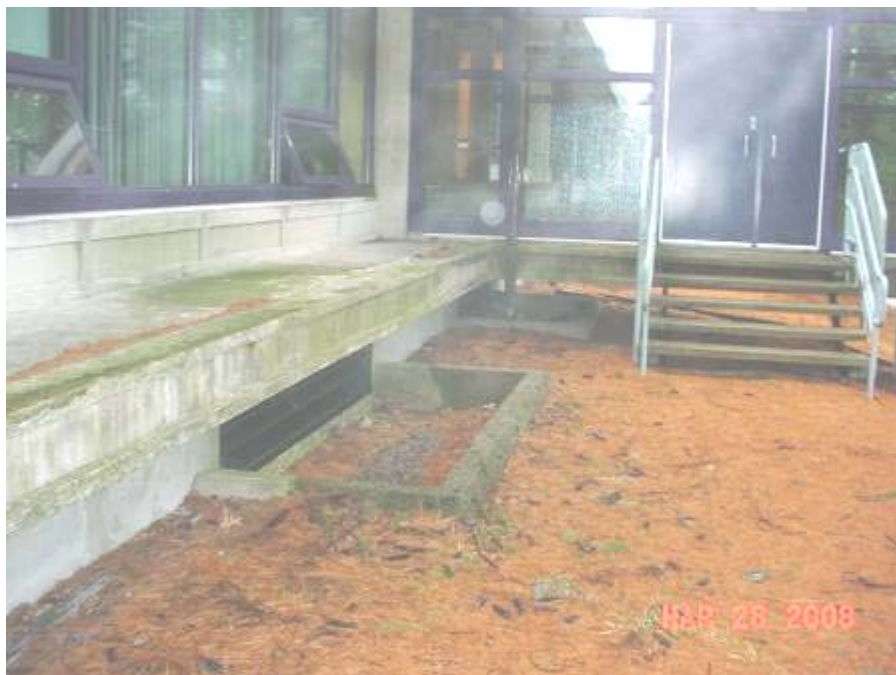
**Picture 18**

- **Media center fresh air intake:** The media center fresh air intake is located in a cement lined pit beneath the ledge near room 305 (Picture 18). The pit faces west and is subject to direct rainfall. Moreover, a drainage hole for the ledge around room 305 empties directly into this fresh air intake pit (Picture 19). On the day of this assessment BEH staff found this pit to be soaked with water as a result of a rainstorm. Additionally, the floor of the pit was covered with a layer of pine needles. This pine needle layer will keep the floor of the fresh air intake pit moist and be a significant source of moisture and related odors that can be captured and distributed by the HVAC system.

**Media center fresh air intake**

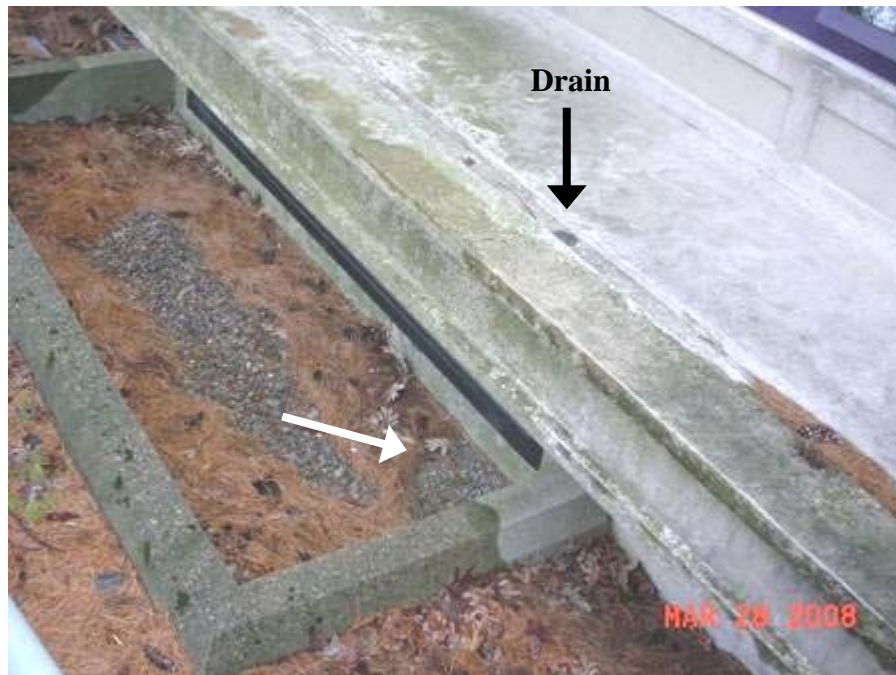
**Picture 19**

**Ledge drainage emptying into fresh air intake;  
note pine needle disturbance and gravel accumulation**

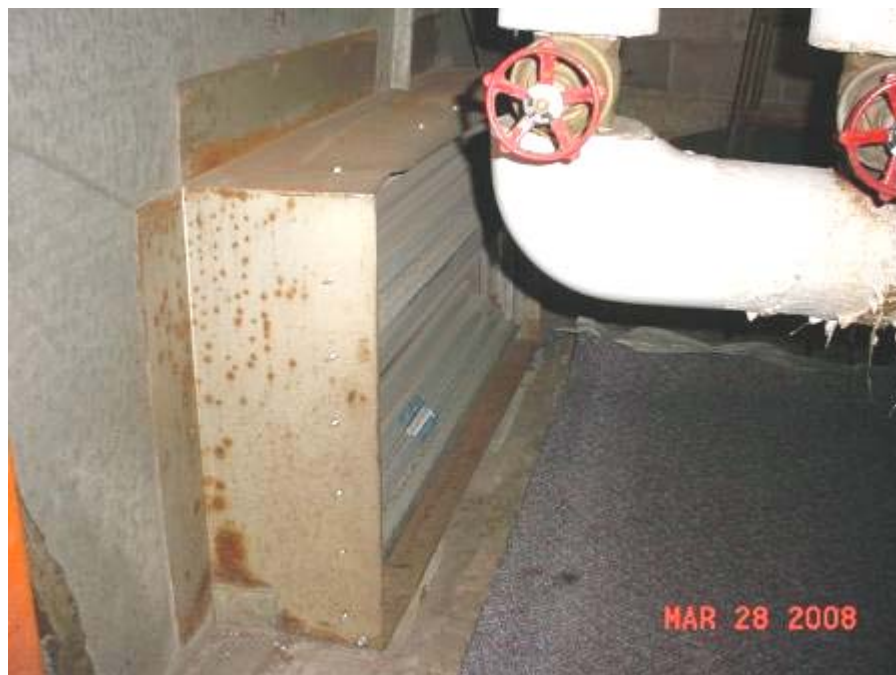
**Picture 20**

**Media center AHU air intake**

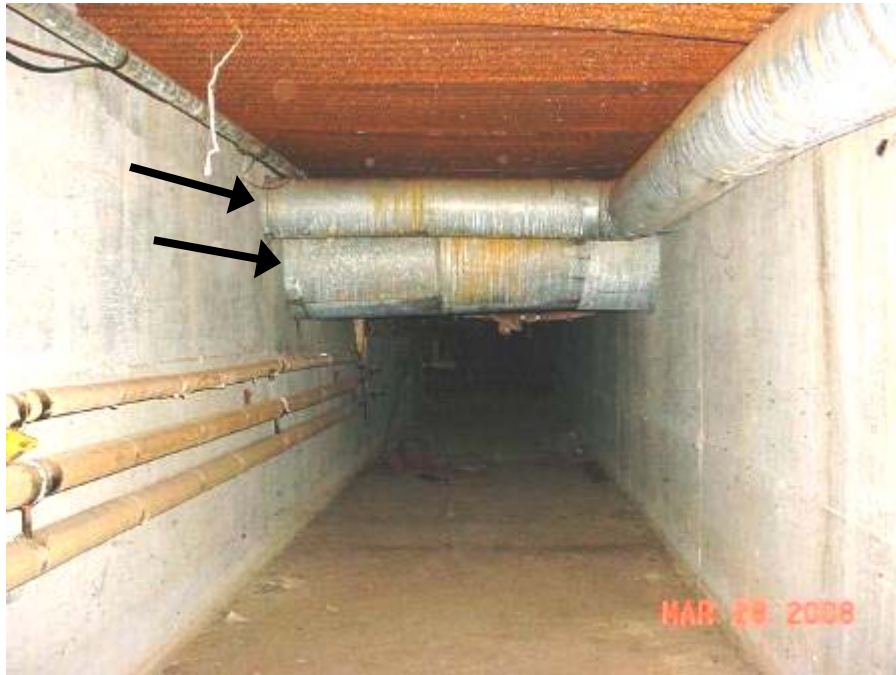
**Picture 21**

**Media center duct work located partially in slab**

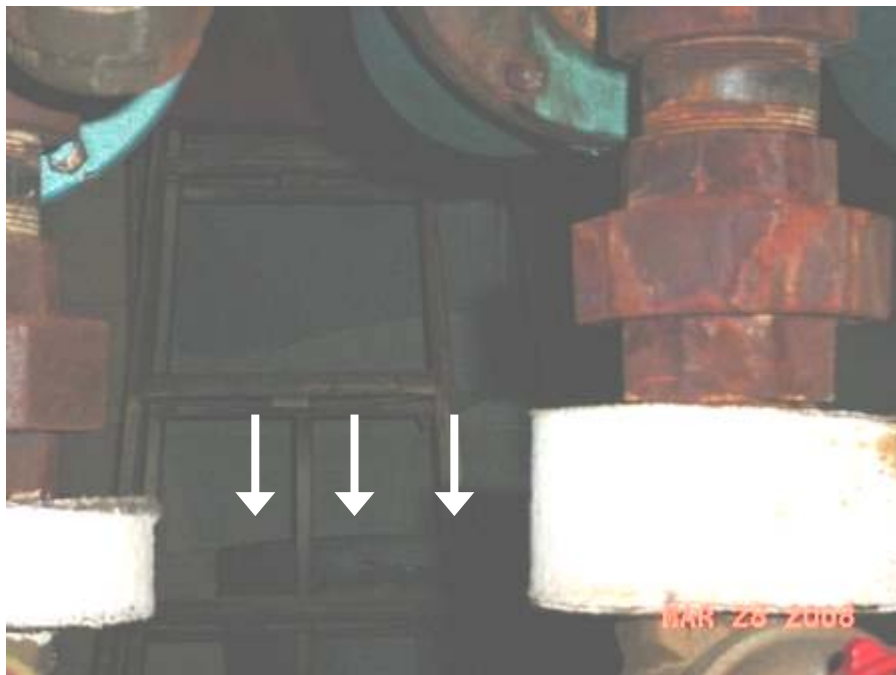
**Picture 22**

**AHU return duct terminating in wall of AHU room**

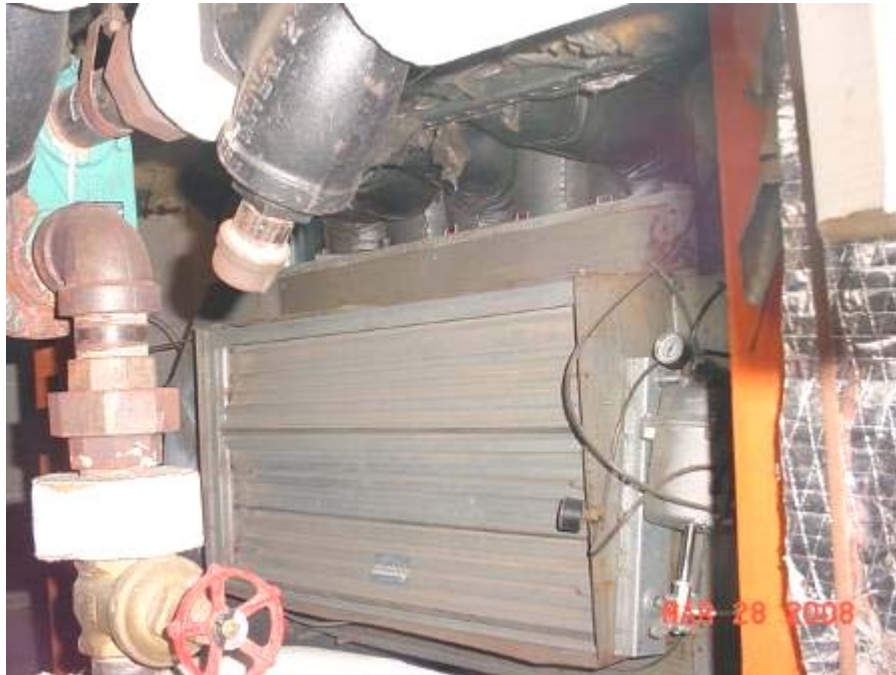
**Picture 23**

**Return air vent open to AHU room**

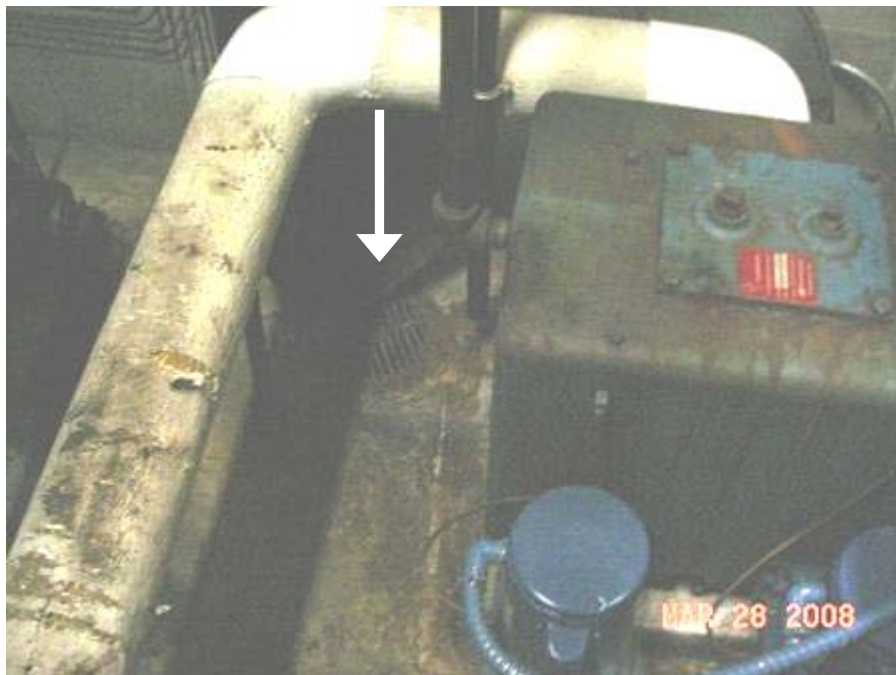
**Picture 24**

**AHU room floor drain**

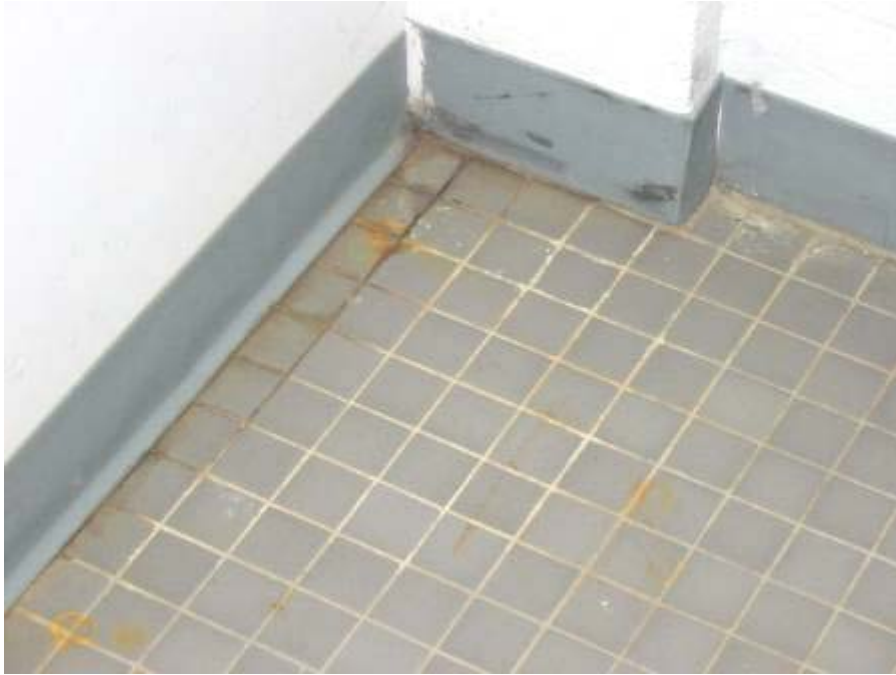
**Picture 25**

Leaks were reported by building occupants in a number of areas in the West Wing. BEH staff observed water stains in the corner of a restroom adjacent to the Speech and Language room (Picture 25). Staff reported that the staining resulted from flooding the bathroom. Staff also reported that occasional flooding occurs in the Speech and Language Office.

**Water stains on bathroom floor**

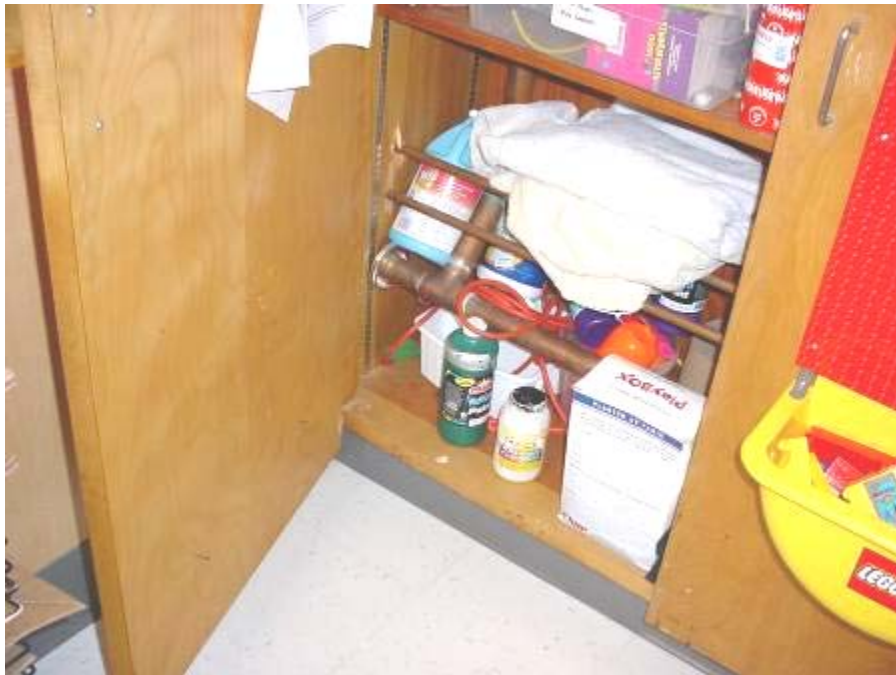
**Picture 26**

Occasional water pooling was reported in the bathroom for room 111. Water pooling against the wall area near the bathroom door has reportedly been observed. BEH staff examined the bathroom and the classroom cabinet on the opposite side of this wall. A pipe located within the classroom's cabinet passes into the wall shared by the bathroom and classroom (Picture 26). The pooling water in the bathroom may be an indication that this pipe is either leaking or that condensation may be forming on the pipe.

**Pipes in cabinet off Room 111**

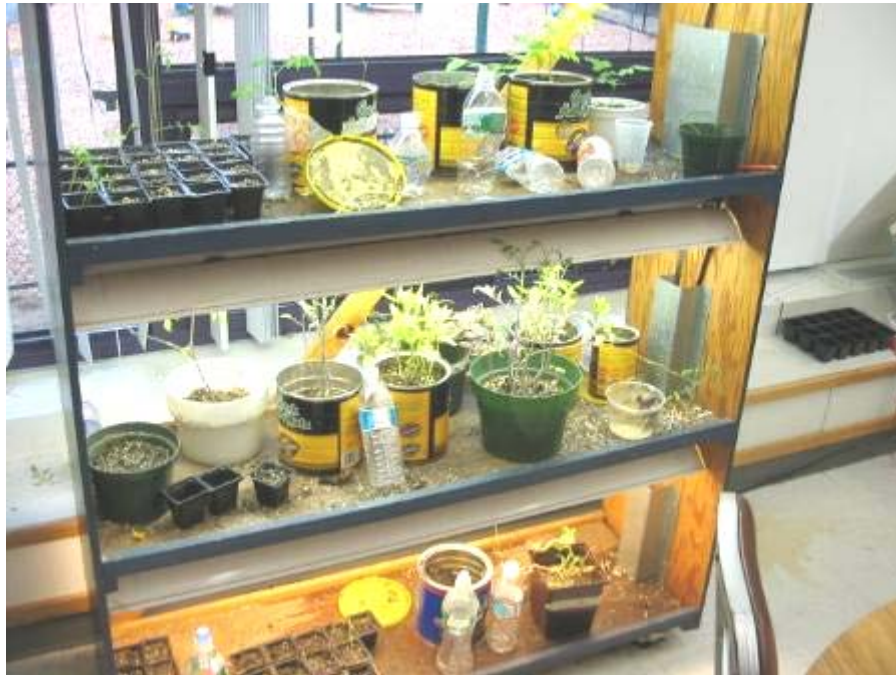
**Picture 27**

BEH staff also observed potential sources for moisture/mold growth in areas throughout the NES. Several classrooms had a number of plants. Classroom 107 had a shelved greenhouse (Picture 27) at the base of which BEH staff observed pooling water (Picture 28), indicating overwatering. Moistened plant soil and drip pans can be a source of mold growth. Plants should be equipped with drip pans; the lack of drip pans can lead to water pooling and mold growth on windowsills. Plants are also a source of pollen. Plants should be located away from the air

**Greenhouse shelf**

24. Seal areas around sinks to prevent water-damage to the interior of cabinets and adjacent wallboard.
25. Ensure plants have drip pans. Examine drip pans periodically for mold growth and disinfect with an appropriate antimicrobial where necessary. Remove plants from the air stream of mechanical ventilation.

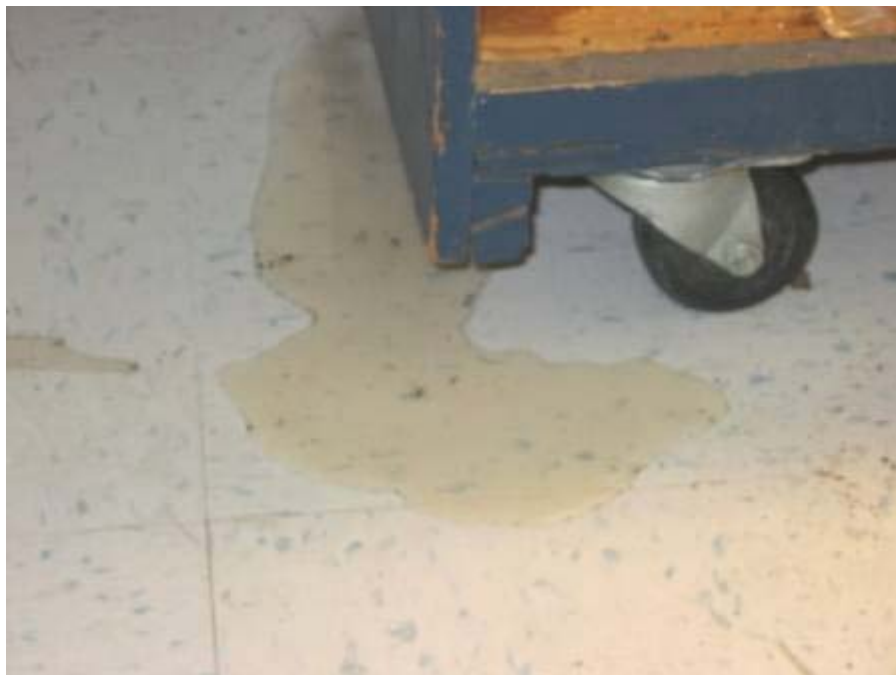
**Picture 28**

**Water at base of greenhouse shelf**

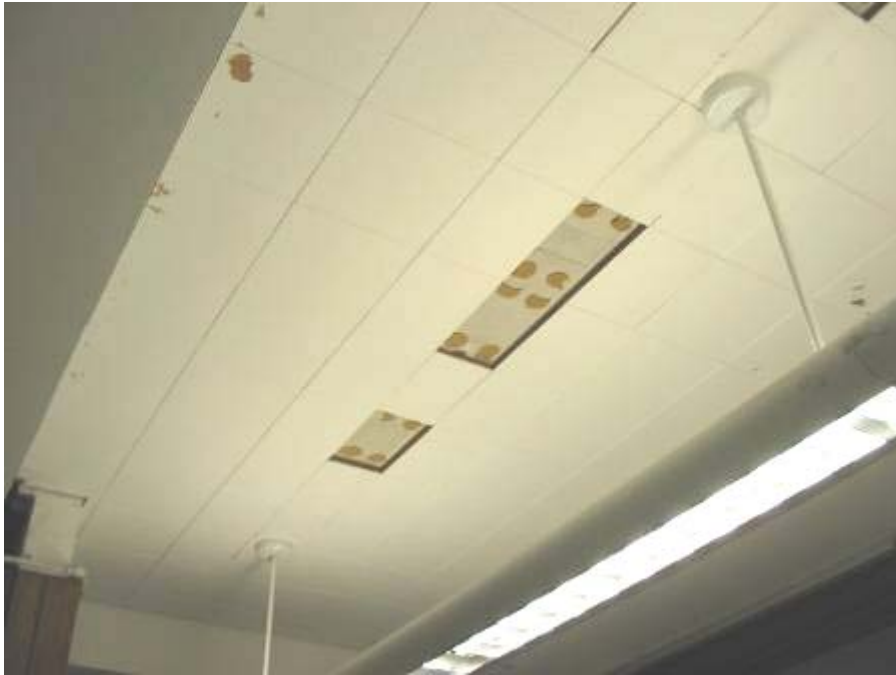
**Picture 29**

A number of classrooms had water-damaged/missing ceiling tiles which can indicate sources of water penetration (Picture 29; Tables 1 and 2). In the gym, the roof drain was leaking, as evidenced by the water-damaged ceiling (Picture 30). In addition, periodic leaks from the skylights were reported in room 305, during wind driven rains. Water-damaged ceiling tiles can provide a source of mold and should be replaced after a water leak is discovered and repaired.

**Missing ceiling tiles**

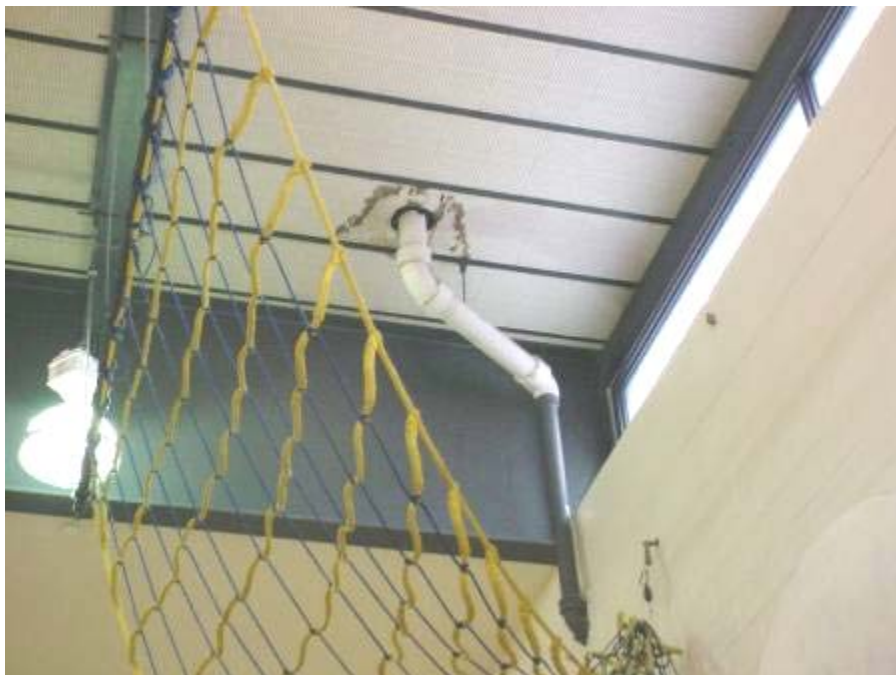
**Picture 30**

**Water-damaged ceiling tiles around roof drain in gymnasium**

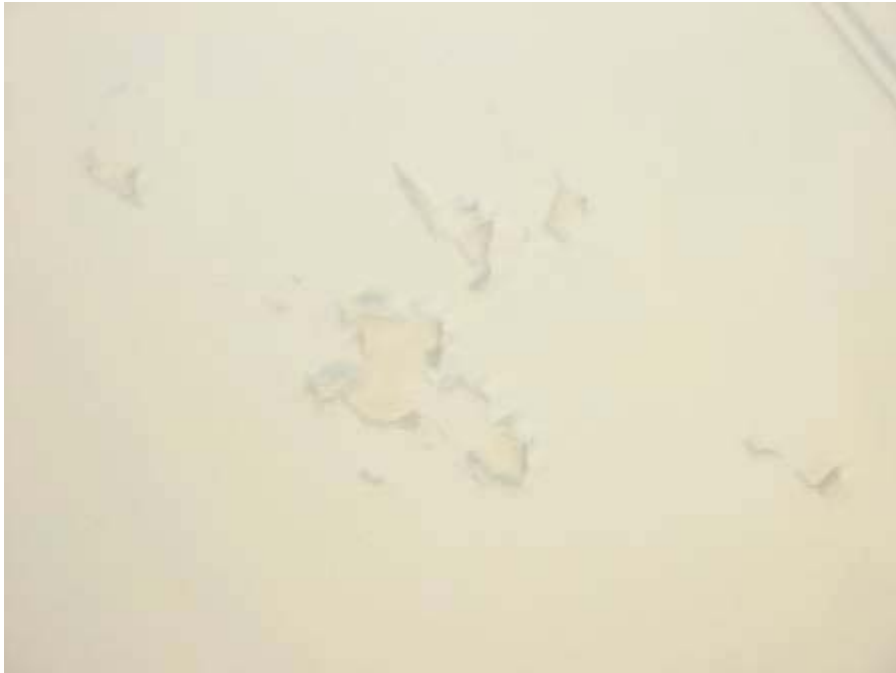
**Picture 31**

Peeling paint was also observed in a few areas (Picture 31). A coat of paint can serve as a water impermeable barrier, which can trap moisture. While plaster is not a viable source for mold growth, water trapped in spaces between the paint and plaster can become mold growth media.

**Peeling paint on plaster**

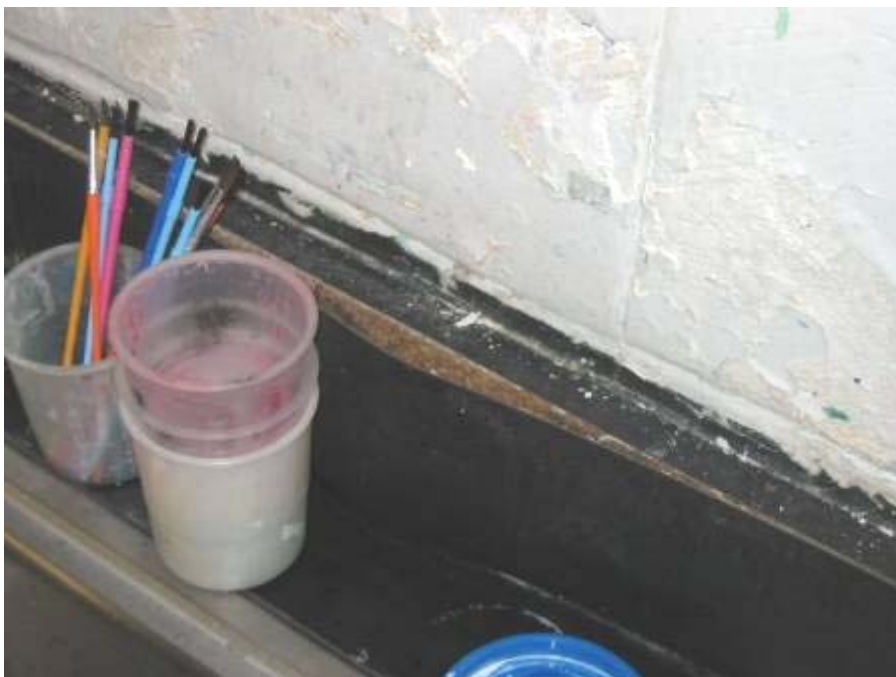
**Picture 32**

Breaches were observed between the counter and sink backsplashes in some classrooms (Tables 1 and 2). If not watertight, water can penetrate through these seams. Improper drainage or sink overflow can lead to water penetration into the countertop, cabinet interior and areas behind cabinets. Water penetration and chronic exposure of porous and wood-based materials can cause these materials to swell and show signs of water damage, which can subsequently lead to mold growth (Picture 32).

**Water-damaged backsplash, peeling paint and wall plaster**

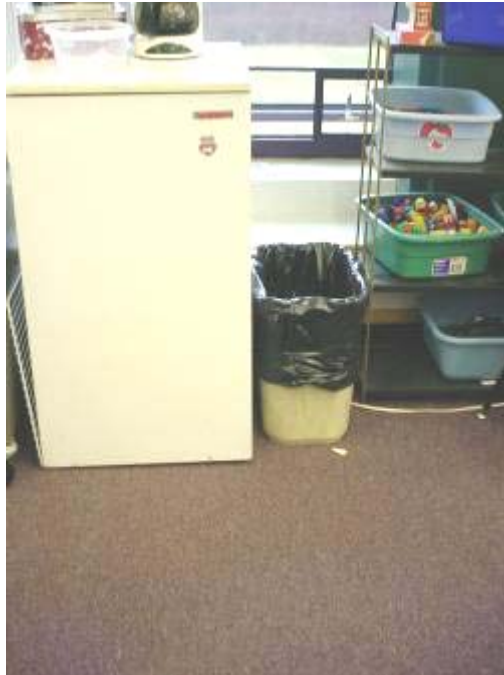
**Picture 33**

Refrigerators were observed on carpeting in a number of areas (Picture 33). When warm, moist air passes over the cooler refrigerator, condensation can collect on the surface. Condensation is the collection of moisture on a surface at or below the dew point. The dew point is the temperature that air must reach for saturation to occur. Over time, condensation can collect and form water droplets. These water droplets can drip from the refrigerator surface to the carpeting. As discussed previously, moistened carpeting can be a source of mold growth.

**Refrigerator on carpeting**

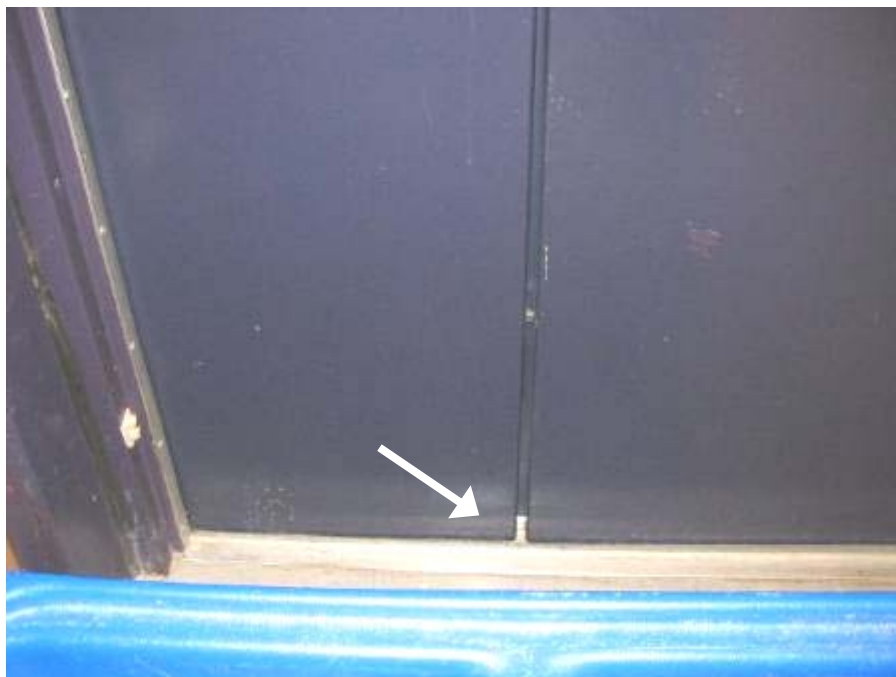
**Picture 34**

Some rooms are equipped with exterior doors. Several of these doors had damaged weather stripping and light could be seen penetrating through the spaces underneath the door from the outdoors (Picture 34). Spaces beneath exterior doors can serve as sources of water entry into the building, causing water damage and potentially leading to mold growth. In addition, these spaces can serve as pathways for insects, rodents and other pests into the building.

**Space in door**

8. Seal all holes in the ceiling, walls and floor of the media center AHU room.
9. Install weather stripping and door sweeps to exterior doors.
10. Repair the exhaust vent in the custodian room adjacent to the media center AHU room.

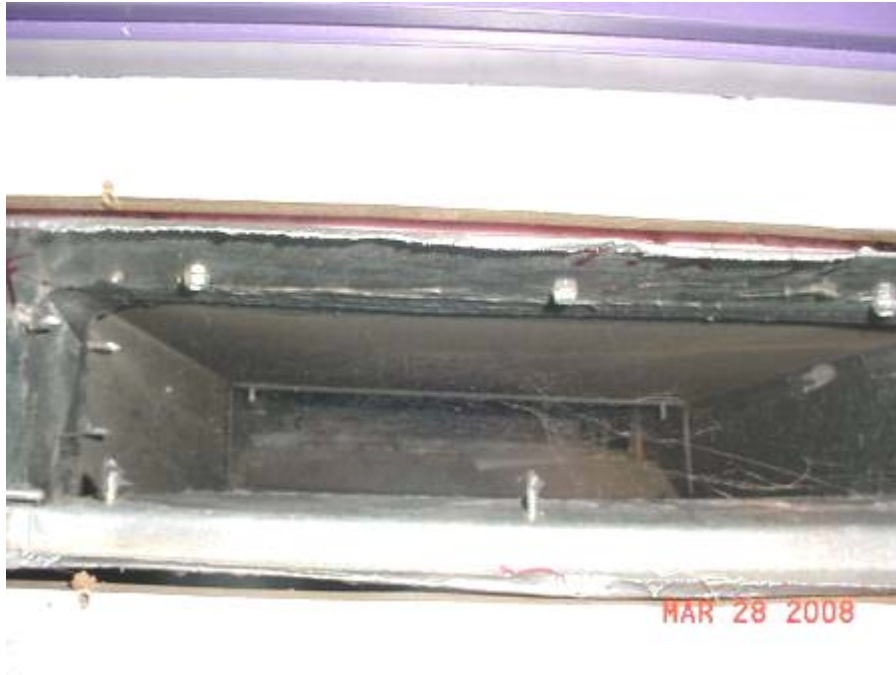
**Picture 35**

Concerns were raised about the presence of degrading insulation within the media center ductwork. The interior of duct appears to be bare sheet metal without any insulation (Picture

**Media center, fresh air supply duct**

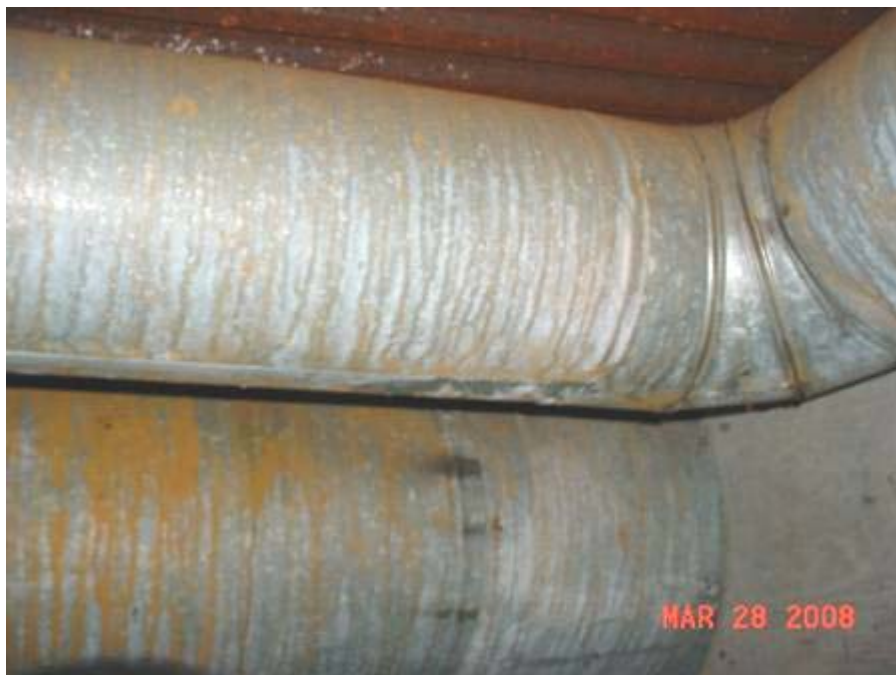
**Picture 36**

35). To investigate this matter further, BEH staff entered the crawlspace beneath the media center. Ductwork supplying air to both the media center and the administration office was also not insulated externally (Picture 36). The lack of insulation in accessible areas of the ductwork would tend to eliminate eroding fiberglass or asbestos insulation as a source of pollutants. The source of fiberglass that were measured in trace amounts in laboratory sampling analyzed by an independent contractor (GAQCI, 2008) is like from damaged pipe insulation inside the east wing south section AHU air mixing room (Picture 20, 24).

**Ductwork in crawlspace**

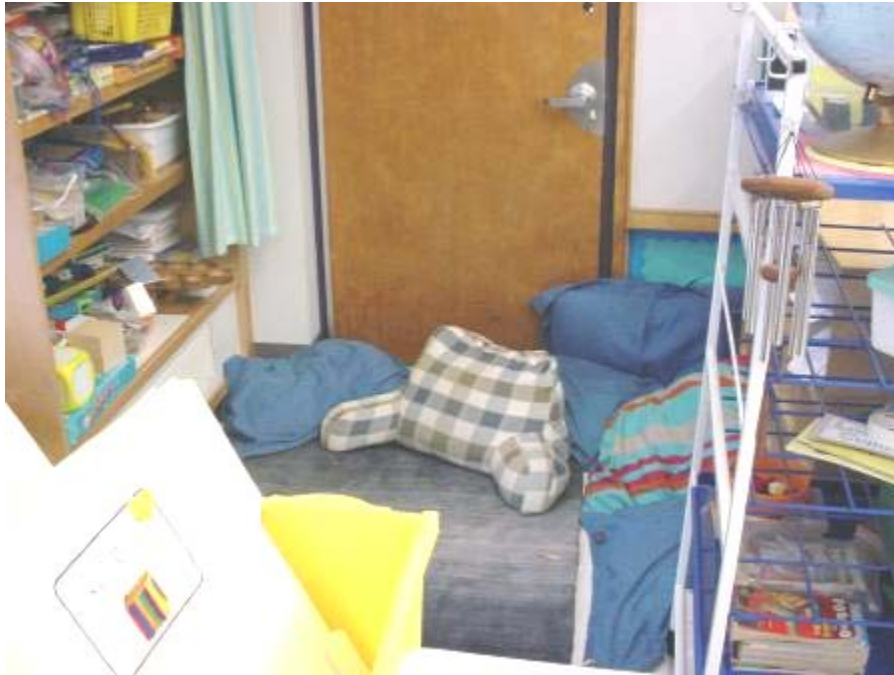
**Picture 37**

Other conditions that can affect indoor air quality were observed during the assessment. In several classrooms, items were observed on the floor, windowsills, tabletops, counters, bookcases and desks (Picture 37). The large number of items stored in classrooms provides a source for dusts to accumulate. These items (e.g., papers, folders, boxes) make it difficult for custodial staff to clean. Items should be relocated and/or be cleaned periodically to avoid excessive dust build up. In addition, these materials can accumulate on flat surfaces (e.g., desktops, shelving and carpets) in occupied areas and subsequently be re-aerosolized causing further irritation.

**Upholstered furniture**
